DATE: April 5, 2010

PRODUCT: ALL 2010/11 BLUE BIRD ALL AMERICAN D3 MODELS

COMPONENT: HORN CONTACT

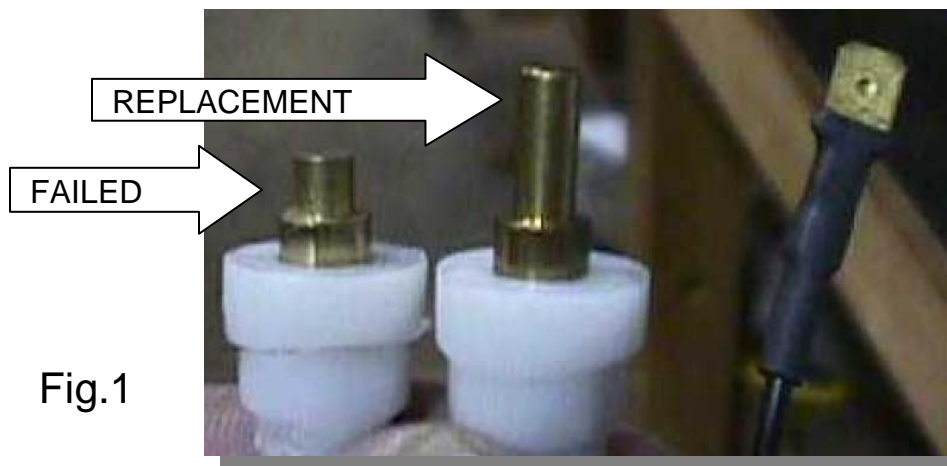
ISSUE: Premature wear of the horn contact (fig.1) located in the steering column (fig.2 #15) may cause the horn to not sound when the horn button is pressed. Blue Bird is aware of the issue and is working on a solution.

REPAIR: If the horn is not working properly inspect the condition of the horn contact (fig.1), if failed, contact your parts representative to order a replacement horn contact part number 10006555, remove the failed contact and install the new contact.
