PRODUCT: 2010/11 BLUE BIRD ALL AMERICAN D3 FRONT ENGINE MODELS  
COMPONENT: ENGINE HEAT CONTROL VALVE

ISSUE: Improper routing of the coolant return line and valve may cause the heater hose to rub on the engine cover damaging the insulation and heater hose

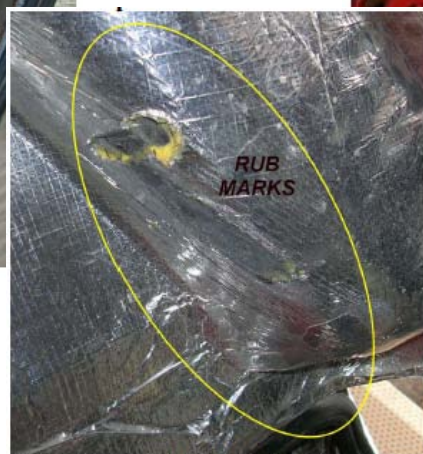
FIGURE #2

REPAIR: Lift the engine cover and inspect for damage, if routed as shown below in figure 1, contact your parts representative and order P/N 00103628 (90 degree elbow), and perform the repair steps below. If the engine cover insulation is damaged, see figure 2, order and replace P/N00118668.
